Berlin Memorial School  
34 South St.  
Berlin, MA 01503

Prepared By: Erik Larson  
Report Date: May 7, 2018

## INTRODUCTION

This report presents the recommendations resulting from the retrocommissioning study performed at the Berlin Memorial School, in Berlin, MA. This study was completed by Guardian Energy Management Solutions (Guardian).

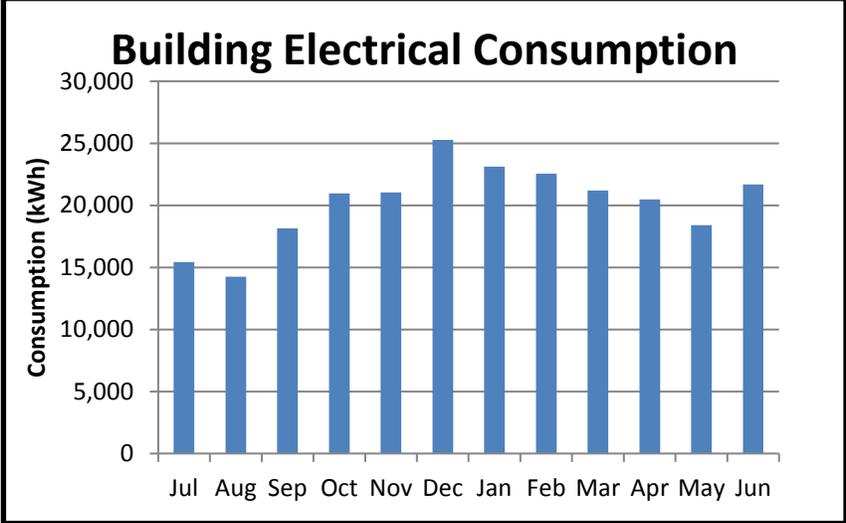
The electricity usage for the building is fairly typical of a facility of this use type. The peak usage in the winter months is most likely due to increased lighting and the use of portable electric heaters, many of which were observed during out audit. The usage peak in the winter is also emphasized by the decrease in the summer months, which is indicative of a school with a summer holiday break. Note that June also has a marked peak. This is the only fully occupied month with both electric hot water heat and extensive air conditioning requirements.

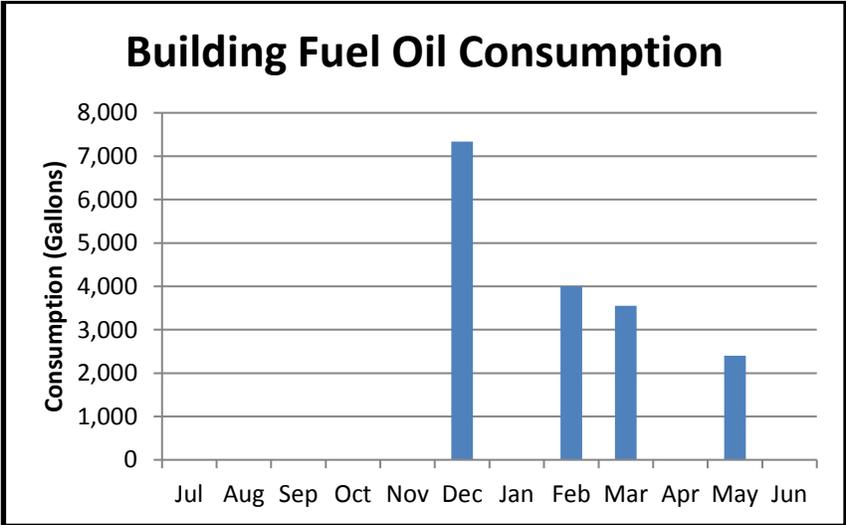
The FY17 fuel oil usage is typical of a building of this type and age. The chart marks oil purchases, and not direct consumption, which explains the peaks.

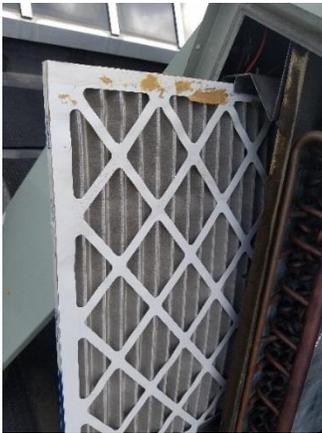
RTU-1 is the rooftop unit that serves the Music Room. It is a constant volume system with a 4 Ton DX cooling coil. It was built in July 1999, and is original to the building. RTU-1 appears to be well maintained and is in good condition for its age. Rooftop units are rated by ASHRAE with a (15) year life expectancy. The cooling coil appeared to be in fair condition. Typical to the RTUs on the building, there has been some coil damage from hail and vandalism. The air filters showed some build up, and we recommend that they get replaced.

RTU-1 filter

There are (2) components that degrade with time in a way that predominantly will affect the performance. The cooling coil can lose 3-6% efficiency every year if not maintained to the manufacturer's recommendations. Regular cleaning and maintenance can return the coil to its original efficiency. The air filters in the unit can inhibit proper airflow if not regularly changed. Replacing the filters every 3-6 months is recommended.

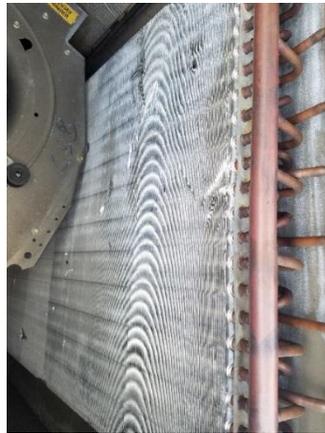
RTU-1 coil

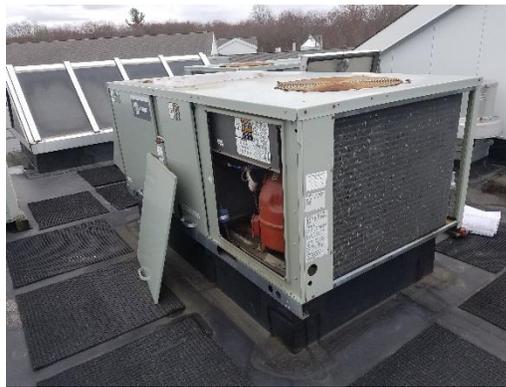
RTU-1 hail damage

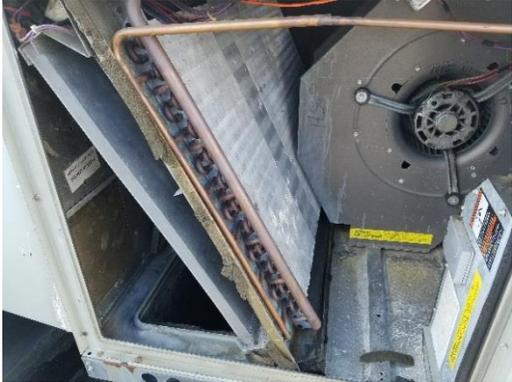
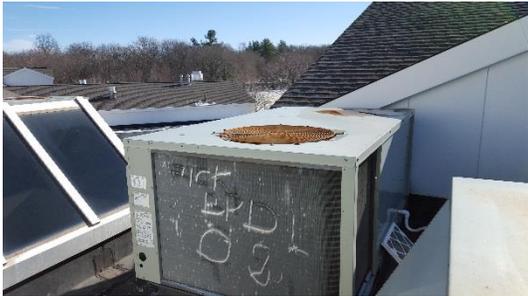
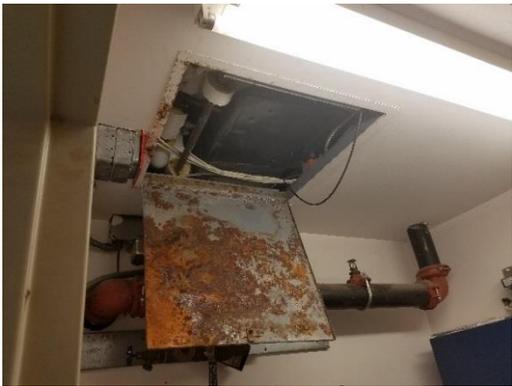
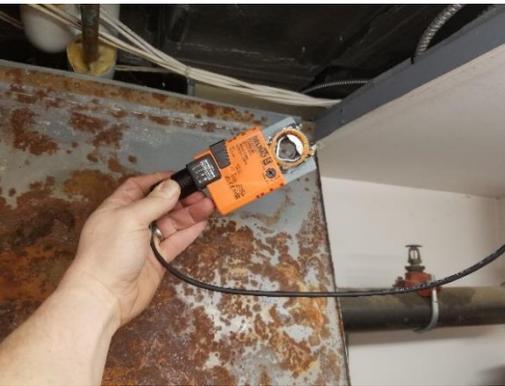
RTU-2 is the rooftop unit that serves the 2<sup>nd</sup> floor offices. It is a constant volume system with a 3 Ton DX cooling coil. It was built in August 1998, and is original to the building. Rooftop units are rated by ASHRAE with a (15) year life expectancy. RTU-2 appears to be well maintained and is in good condition for its age. The cooling coil appeared to be in fair condition. Typical to the RTUs on the building, there has been some coil damage from hail and vandalism. The air filters showed some build up, and we recommend that they get replaced.

While investigating the unit, it was observed that the hot water valve actuator was disconnected from the valve and placed on the opposite side of the access hatch. We re-connected it and it tested fine while maintaining the appropriate temperature range in the served spaces.

There are (2) components that degrade with time in a way that predominantly will affect the performance. The cooling coil can lose 3-6% efficiency every year if not maintained to the manufacturer's recommendations. Regular cleaning and maintenance can return the coil to its original efficiency. The air filters in the unit can inhibit proper airflow if not regularly changed. Replacing the filters every 3-6 months is recommended.

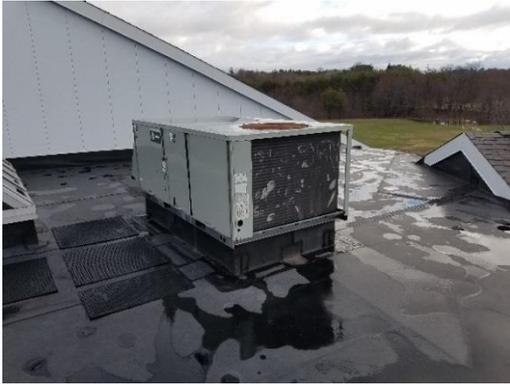
RTU-3 hail damage

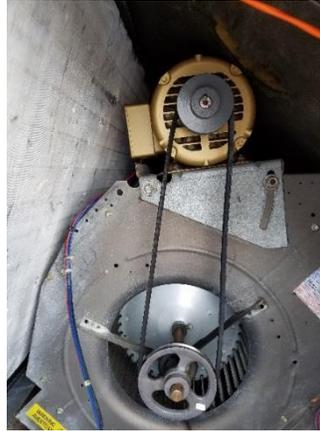
RTU-3 is the rooftop unit that serves the Library. It is a constant volume system with a 7.5 Ton DX cooling coil. It was built in August 1998, and is original to the building. Rooftop units are rated by ASHRAE with a (15) year life expectancy. RTU-3 appears to be well maintained and is in good condition for its age. The fan belt appeared to be cracking slightly and squeaking loudly, replacement and re-tensioning are recommended. The cooling coil appeared to be in fair condition. Typical to the RTUs on the building, there has been some coil damage from hail and vandalism. The air filters showed some build up, and we recommend that they get replaced, and that the cooling coil is cleaned as recommended by the manufacturer. During the audit, the barometric relief blade was observed to be disconnected and resting in the opening it was intended to block. It was replaced into its intended position.

RTU-3 general condition

There are (3) components that degrade with time in a way that predominantly will affect the performance. The cooling coil can lose 3-6% efficiency every year if not maintained to the manufacturer's recommendations. Regular cleaning and maintenance can return the coil to its original efficiency. The fan belt can lose significant efficiency if not properly tensioned, and all belts should be replaced annually to ensure optimal performance. The air filters in the unit can inhibit proper airflow if not regularly changed. Replacing the filters every 3-6 months is recommended.

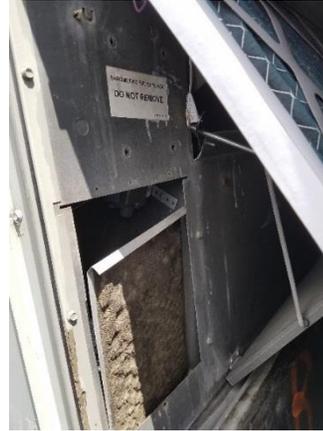
RTU-3 barometric relief damper

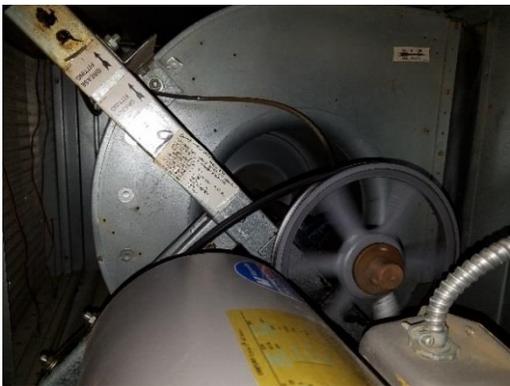
AHU-1+2 are the air handling units that serve the gymnasium. They are constant volume heating and ventilations, built in 1999, and are original to the building. Air handling units are rated by ASHRAE with a (15) year life expectancy. AHU-1+2 appear to be in fair condition for their age. The belts and coils appear to be in good condition and the unit needs routine cleaning and new air filters. Due to the lack of safe access to AHU-2, only AHU-1 was opened and surveyed.

The 3 HP supply fan motor appears to be original to the installation. It has a rated efficiency of 85.5%, and the NEMA premium efficiency minimum for this size motor is currently 89.5%.

AHU-1 general condition

There are (3) components that degrade with time in a way that predominantly will affect the performance. The heating coil can lose 3-6% efficiency every year if not maintained to the manufacturer's recommendations. Regular cleaning and maintenance can return the coil to near its original efficiency. Fan belts can lose significant efficiency if not properly tensioned, and all belts should be replaced annually to ensure optimal performance. The air filters in the unit can inhibit proper airflow if not regularly changed. Replacing the filters every 3-6 months is recommended.

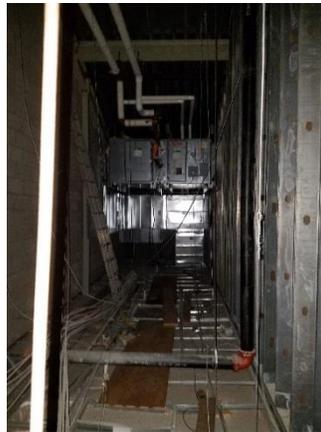
AHU-2 access across drop ceiling

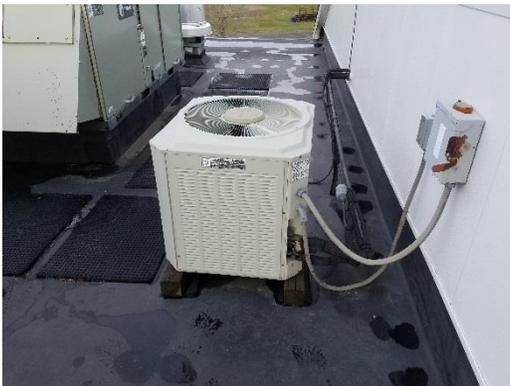
HVAC-1 is the Split System A/C unit that serves the 2<sup>nd</sup> floor offices. It is a constant volume system with a 3 Ton DX cooling coil. It was built in July 1998, and is original to the building. Split systems units are rated by ASHRAE with a (15) year life expectancy. HVAC-1 appears to be well maintained and is in good condition for its age. The cooling coil appeared to be in good condition, and seasonal maintenance would restore it to the original efficiency. The air filters showed some build up, and we recommend that they get replaced.

HVAC-1 condenser

There are (3) components that degrade with time in a way that predominantly will affect the performance. The cooling coil can lose 3-6% efficiency every year if not maintained to the manufacturer's recommendations. Regular cleaning and maintenance can return the coil to its original efficiency. The air filters in the unit can inhibit proper airflow if not regularly changed. Replacing the filters every 3-6 months is recommended. The belts on the unit showed some cracking. Replacement and re-tensioning are recommended.

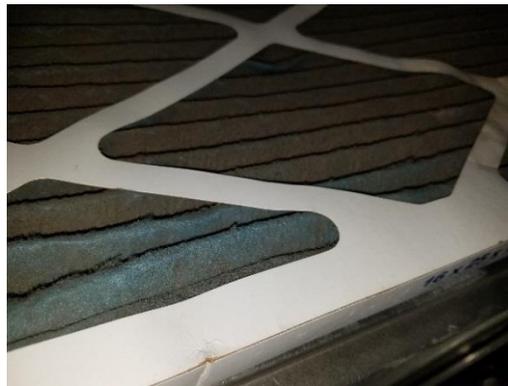
HVAC-1 filter

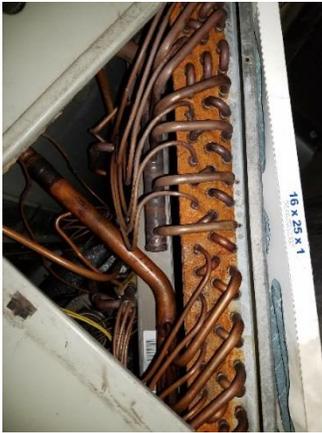
HVAC-2 is the Split System A/C unit that serves the kitchen and Cafeteria. It is a constant volume system with a 10 Ton DX cooling coil. It was built in August, 1998 and is original to the building. Split systems units are rated by ASHRAE with a (15) year life expectancy. HVAC-2 appears to be well maintained and is in good condition for its age. Typical to the equipment on the roof, there has been some coil damage from hail and vandalism. The air filters showed some build up, and we recommend that they get replaced.

HVAC-2 general condition

There are (3) components that degrade with time in a way that predominantly will affect the performance. The cooling coil can lose 3-6% efficiency every year if not maintained to the manufacturer's recommendations. Regular cleaning and maintenance can return the coil to its original efficiency. The air filters in the unit can inhibit proper airflow if not regularly changed. Replacing the filters every 3-6 months is recommended. The belts on the unit showed some cracking. Replacement and re-tensioning are recommended.

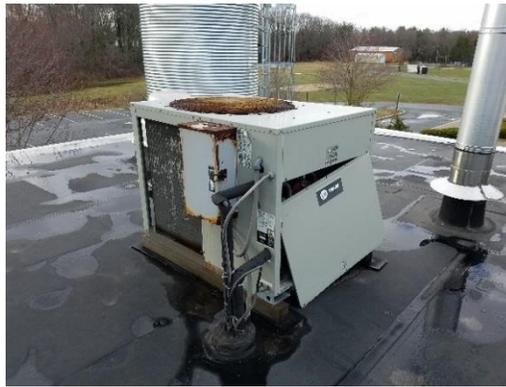
HVAC-2 condenser

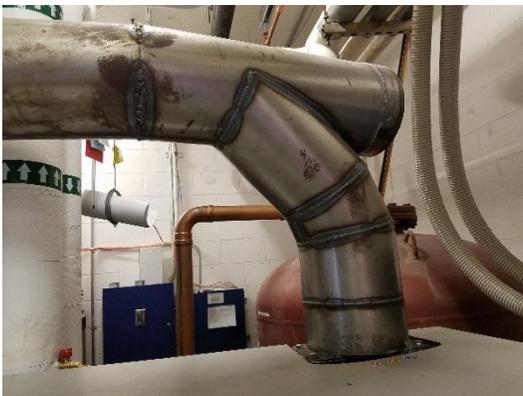
During the audit, the hot water bypass damper on B-1 was observed clicking constantly, and appeared to be stuck, attempting to rotate. Immediate efforts to resolve the issue were unsuccessful. The unit appeared to be operating normally otherwise. During the previous audit, it had been observed that the flue stack for these boilers had some welding that was insufficient, poorly executed, and due to this, had leaks. It was observed that all of the welds on the stack have been re-welded, and now are all in good condition.

B-1+2 flue welds

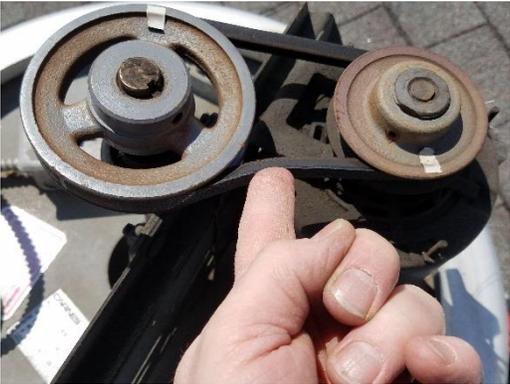
The exhaust fan motors all appear to be original to the building, manufactured in the 1998-1999 time period. They are generally in good condition for their age, though replacing and re-tensioning the fan belts is recommended.

EF-5 belt and general fan condition

The fan belts on these units are in a variety of conditions. Annual replacement and tensioning are recommended.

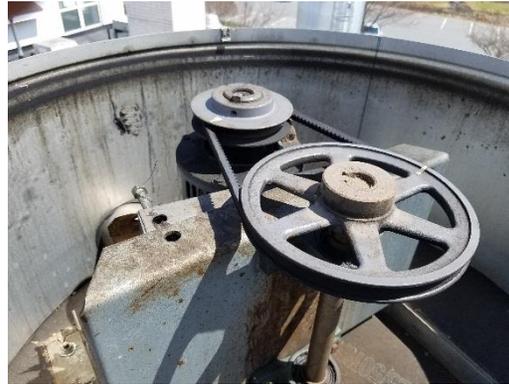
EF-6 belt and general fan condition

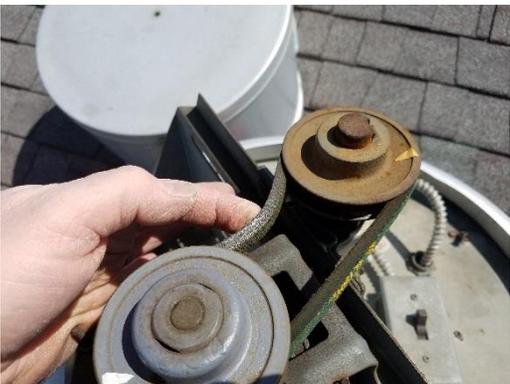
EF-7 belt and general fan condition

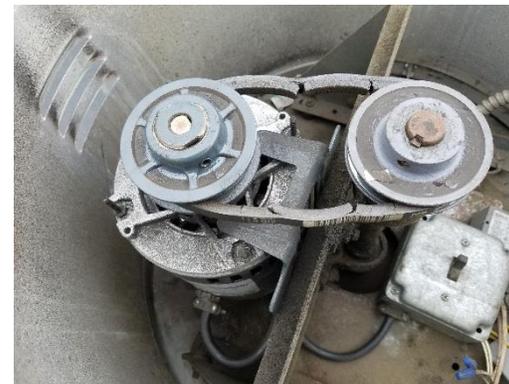
EF-11 belt and general fan condition

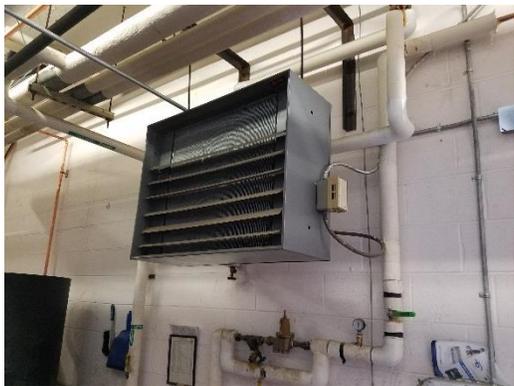
The unit heater in the mechanical room is a 172 MBH hot water unit heater, original to the 1999 building. ASHRAE rates hot water unit heaters with a (20) year life expectancy. While replacing this heater will not result in a significant energy efficiency upgrade, it is nearing the end of its useful life.

UH-1 general condition

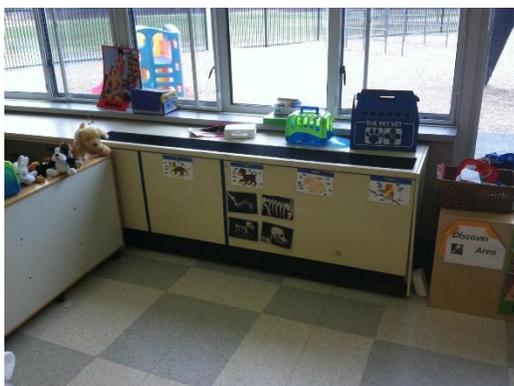
The unit ventilators were generally found to be in fair condition for their age. Many had filters that needed changed, and coils and internal compartments that needed cleaning.

CUV general condition

There are (2) components that degrade with time in a way that predominantly will affect the performance. The cooling coil can lose 3-6% efficiency every year if not maintained to the manufacturer's recommendations. Regular cleaning and maintenance can return the coil to its original efficiency. The air filters in the unit can inhibit proper airflow if not regularly changed. Replacing the filters every 3-6 months is recommended.

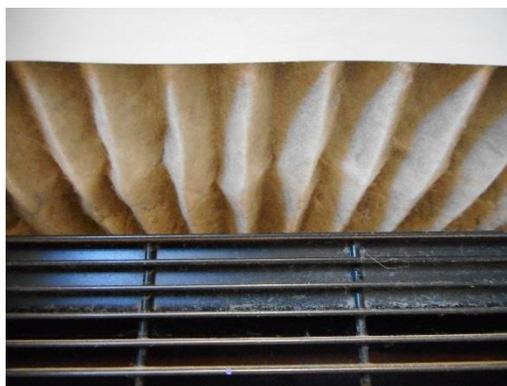
CUV filter (typical)
